FURNACE FLOOR TUBE

METALLOGRAPHIC INVESTIGATION OF FURNACE FLOOR TUBE #48 WITH LOCAL WALL THINNING; RECOVERY BOILER

REGISTRATION NUMBER: M013761

DATE: 2005-10-04

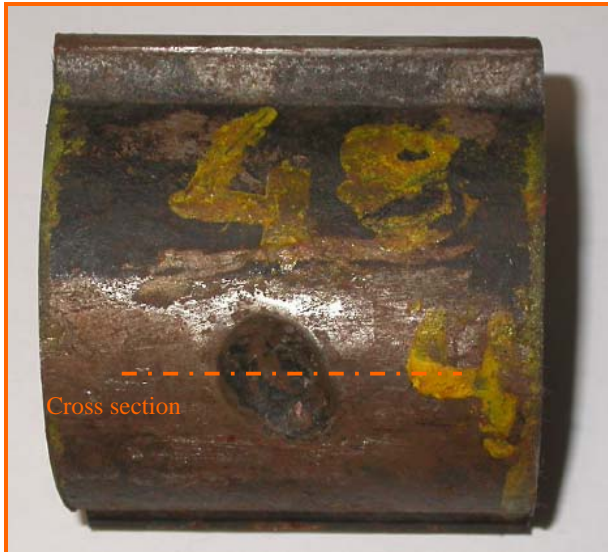
We received one tube sample from furnace floor tube from recovery boiler . The tube sample had a length of about 65 mm with the dimension of \varnothing 63 x 6.4 mm (measured values). See fig.1 and 2 on page 4.

One cross section (parallel to tube axis) was cut out from the area with local thinning, for investigation. For location of the cross section, see fig.1 on page 4. The cross section was prepared and investigated in not etched and etched condition at magnification up to 800 \times . The cross section was etched with nital (etchant A.1 according to SIS-CEN/CR 12361:1996, similar to etchant 74 according to ASTM E 407-99).

Fig.1: Received tube sample with local wall thinning on furnace side. Location of cross section as in fig. above.

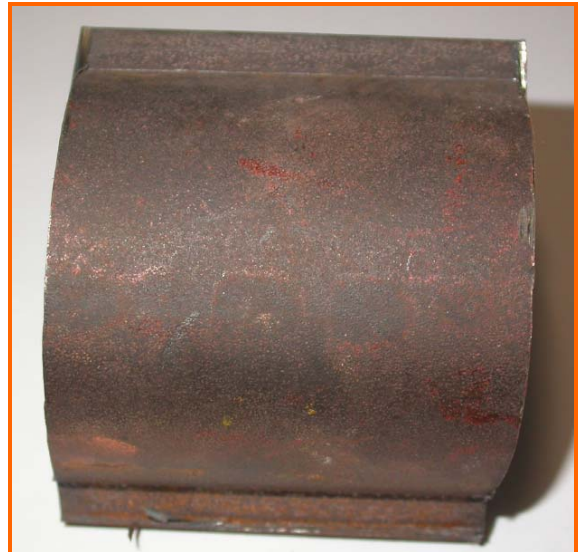
Fig.2: Same tube sample seen from insulation side.

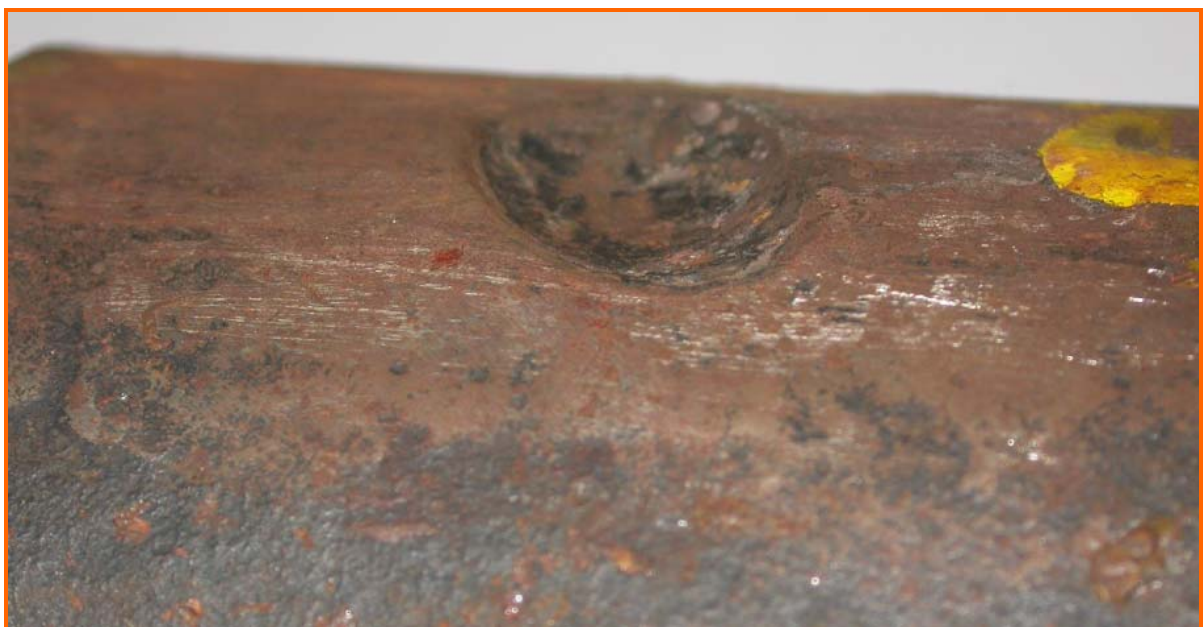
On gas-side towards furnace side we observed a limited region with local thinning (with a surface area of about 20×14.5 mm). See fig.3 on page 4.

Fig.3: Close-up view of area with local wall thinning.

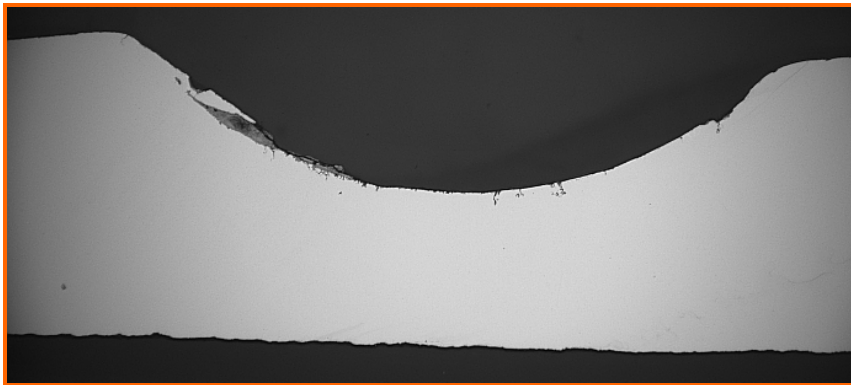
Wall thinning We observed an area with local wall thinning. The minimum wall thickness, in area with local thinning, was measured to 3.2 mm. See fig.6 on page 6.

The wall thinning was calculated to 3.2 mm (which is equal to a 50 % reduction of the wall thickness).

Fig.6: Cross section. Local wall thinning. Minimum wall thickness was measured to 3.2 mm. Not etched. 7 \times .

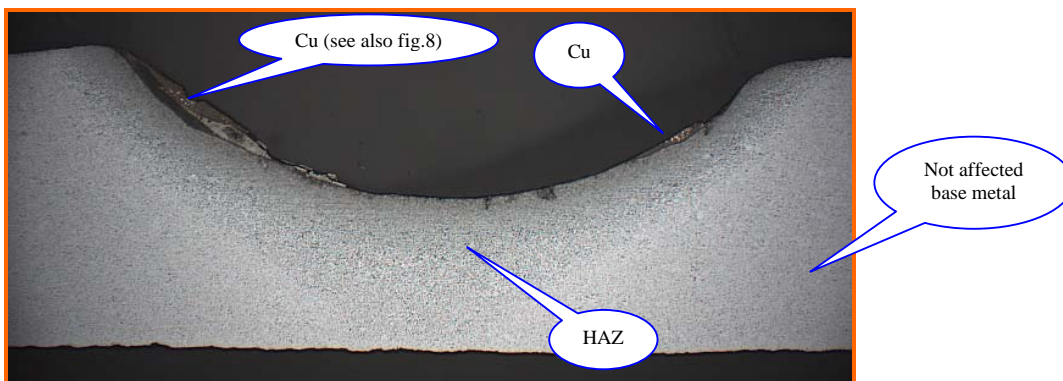
At wall thinning: The structure showed a heat-affected zone (HAZ). See fig.7 on page 6.

Copper We observed large amount of copper inclusions in the zone with different structure. In some areas we observed copper with intergranular extension in the heat affected zone (not the melted zone), indicating copper penetration. See fig.7 to 14 on page 6 to 9. Spectral analysis (x-ray spectra) established that the inclusions consisted of copper.

Fig.7: Same area as in fig.6, in etched condition. We observed a heat affected zone (HAZ) in the area where we observed local wall thinning. We observed occurrence of copper (Cu) towards gas-side. Nital. 7 \times .

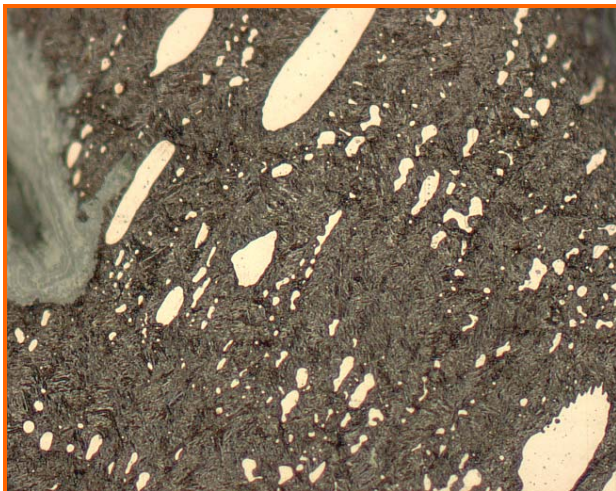
Towards gas-side, in area with wall thinning, we observed a zone with different structure (structural change), probably because part of the tube towards gas-side had been melted. The structure in that zone had not been established, but the hardness indicates a hardening structure. See fig.10 on page 7.

1.	481 HV
2.	257 HV
3.	145 HV

Fig.10: Same area as in fig.9, in etched condition. The structure consisted of a hardening structure (the hardness of the structure was measured to 481 HV). Nital. 400 \times .

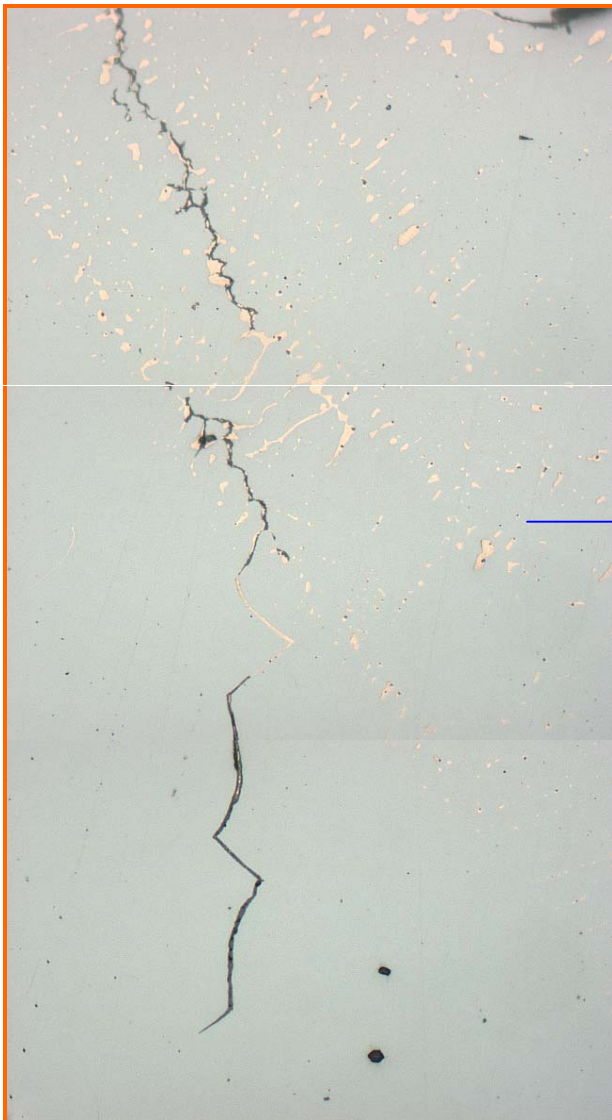
Fig.11 ¹⁾: Cracks (filled with oxides and copper). Not etched. 400×.
The cracks were mainly concentrated to areas with copper (inclusions).

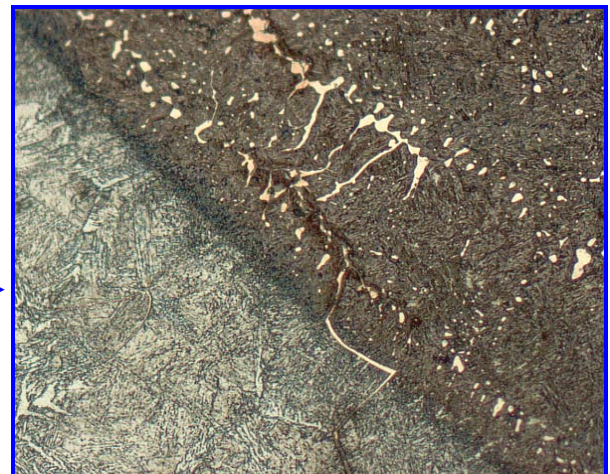
Fig.12: Part of area shown in fig.11, in etched condition.
Nital. 400×.
